The 2015 Gorkha Nepal earthquake: insights from earthquake damage survey

Katsuichiro Goda^{1*}, Takashi Kiyota², Rama Mohan Pokhrel², Gabriele Chiaro², Toshihiko Katagiri², Keshab Sharma³ and Sean Wilkinson⁴

The 2015 Gorkha Nepal earthquake caused tremendous damage and loss. To gain valuable lessons from this tragic event, an earthquake damage investigation team was dispatched to Nepal from 1 May 2015 to 7 May 2015. A unique aspect of the earthquake damage investigation is that first-hand earthquake damage data were obtained 6–11 days after the mainshock. To gain deeper understanding of the observed earthquake damage in Nepal, the paper reviews the seismotectonic setting and regional seismicity in Nepal and analyzes available aftershock data and ground motion data. The earthquake damage observations indicate that the majority of the damaged buildings were stone/brick masonry structures with no seismic detailing, whereas the most of RC buildings were undamaged. This indicates that adequate structural design is the key to reduce the earthquake risk in Nepal. To share the gathered damage data widely, the collected damage data (geo-tagged photos and observation comments) are organize

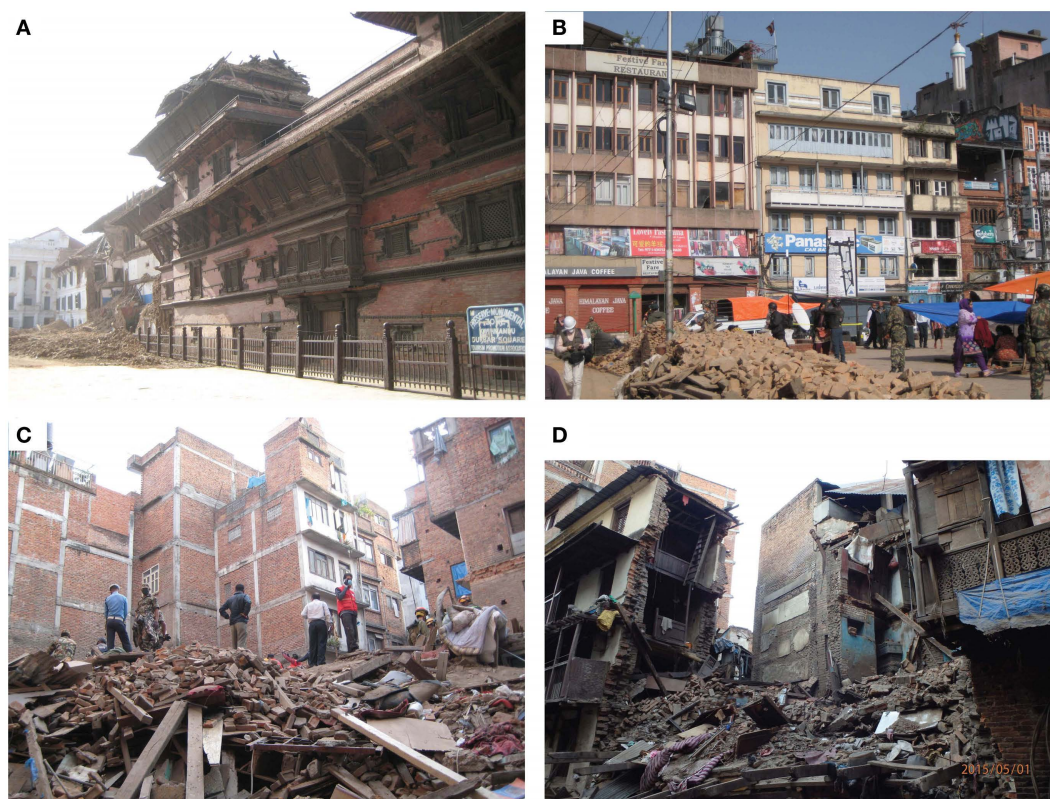
Many historical buildings in the Kathmandu Durbar Square (in front of the Old Royal Palace of the former Kathmandu Kingdom and is a UNESCO World Heritage site) were devastated (area 1 in **Figure 4**). **Figure 8A** shows the collapse of the Basantapur Tower. The complete destruction in the Durbar Square was in sharp contrast with undamaged buildings surrounding the Durbar Square (**Figure 8B**; several wall cracks can be found on these buildings;

however, the majority of the masonry buildings are structurally stable). This indicates that the ground shaking experienced in this area (note: this is relatively close to the KATNP station; see **Figure 4**) was sufficient to cause the collapses of the old historical buildings but was not to cause severe damage to the surrounding buildings. This observation was confirmed by walking through the Indra Chowk area (market squares near the Old Palace), where many old masonry buildings (three to six stories) were densely constructed. Nevertheless, there were several buildings that collapsed completely and some search and rescue activities were undertaken (**Figures 8C,D**).

FIGURE 8 | Damage in Kathmandu (area 1 in Figure 4). (A) Collapse of the Basantapur Tower in the Kathmandu Durbar Square. **(B)** Undamaged buildings opposite of the Basantapur Tower in the Kathmandu Durbar Square. **(C)** Collapse of four 5- or 6-story old masonry buildings. **(D)** Collapse of a 4-story masonry building.

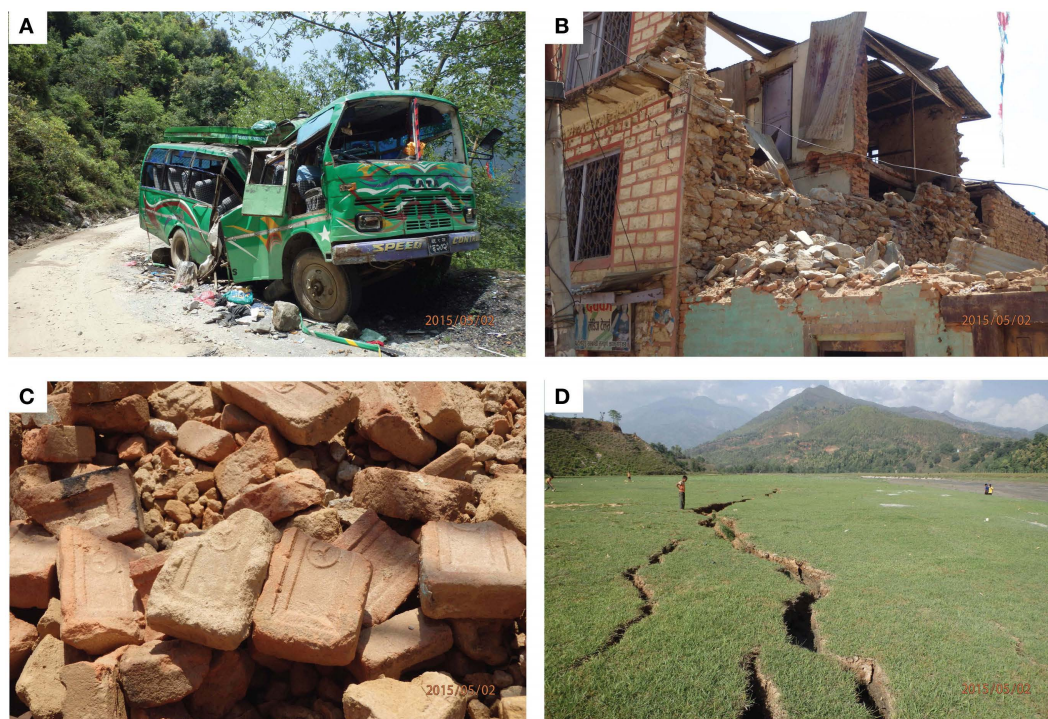
hydroelectric station. Trishuli was closer to the hypocenter of the M_w 7.8 mainshock, and thus severer damage, in comparison with Kathmandu, was expected. Along the way to Trishuli, earthquake damage in Ranipauwa (about 15 km north–west of Kathmandu) appeared relatively minor. Proceeding further north–west, earthquake damage to houses and landslides along the mountain slopes were observed more frequently. The rock fall, as secondary hazard, can be dangerous; a bus was hit by fallen boulder and several people were killed (**Figure 11A**). In Battar (about 25 km north–west of Kathmandu), a large number of brick/stone masonry buildings were collapsed (**Figure 11B**). The building materials of these damaged buildings were of poor quality; for example, two different types of the fragile bricks were used in one of the damaged houses (**Figure 11C**). According to local residents, many buildings were collapsed due to the 25 April M_w 6.6 aftershock, which occurred 30 min after the mainshock.

In Trishuli, there was an earth fill dam for hydroelectric power generation. The main body of the dam was the excavated and compacted soil. The height of the dam was 12 m (upstream side) and 20 m (downstream side), and the crest width was about 4 m. Due to the earthquake, there were cracks at upstream side of the dam and fissures on the crest. Moreover, liquefaction (as evidenced by silt boils) and lateral spreading (**Figure 11D**) occurred inside of the dam reservoir due to the earthquake. The operation of the power generation had been suspended since the

following day of the mainshock; at the time of the visit, no power was available in nearby villages. Overall, the earthquake damage to the Trishuli dam will not cause severe problems immediately. However, the extent of cracking along the dam axis may suggest a deterioration of the dam body, which may be accelerated into the dam failure by future earthquakes or penetration of rain water into the dam body through cracks. It is important to mention that in worst-case scenarios (note: this earthquake is not the extreme case in terms of ground shaking intensity), catastrophic dam failures could have been caused. As there are several major hydroelectric projects along the Trishuli River as well as in other major rivers in Nepal, ensuring dam safety against large earthquakes is important.

FIGURE 11 | Damage in Trishuli (see Figure 3). (A) Destroyed bus due to boulder fall. **(B)** Damaged brick masonry house in Battar. **(C)** Different types of bricks used in the damaged masonry house in Battar. **(D)** Ground fissures in the Trishuli dam reservoir.
